What a Drag it is Getting Older

Or, how you sometimes end up with more than all-wheel drive to grip the road

Winter Park, April 2011

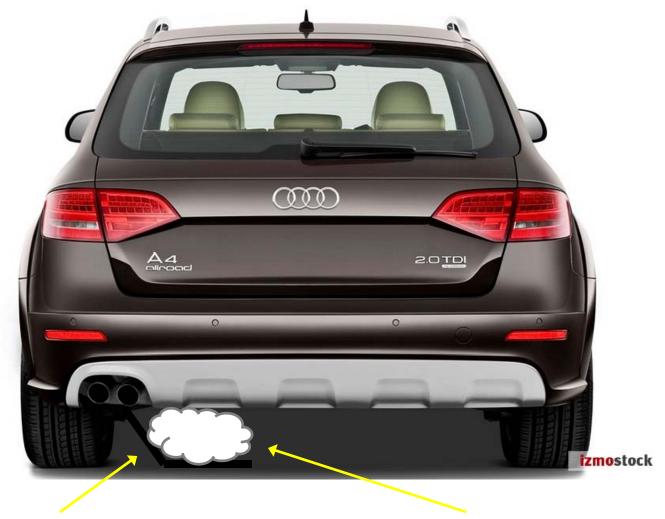
Plastic driver-side underbody fairing (measuring front-to-back from just behind front wheel to just before rear wheel), shown in "extended" position

Large, heavy chunk of snow/ice covering the entire plastic fairing, pushing the latter down firmly on the road surface

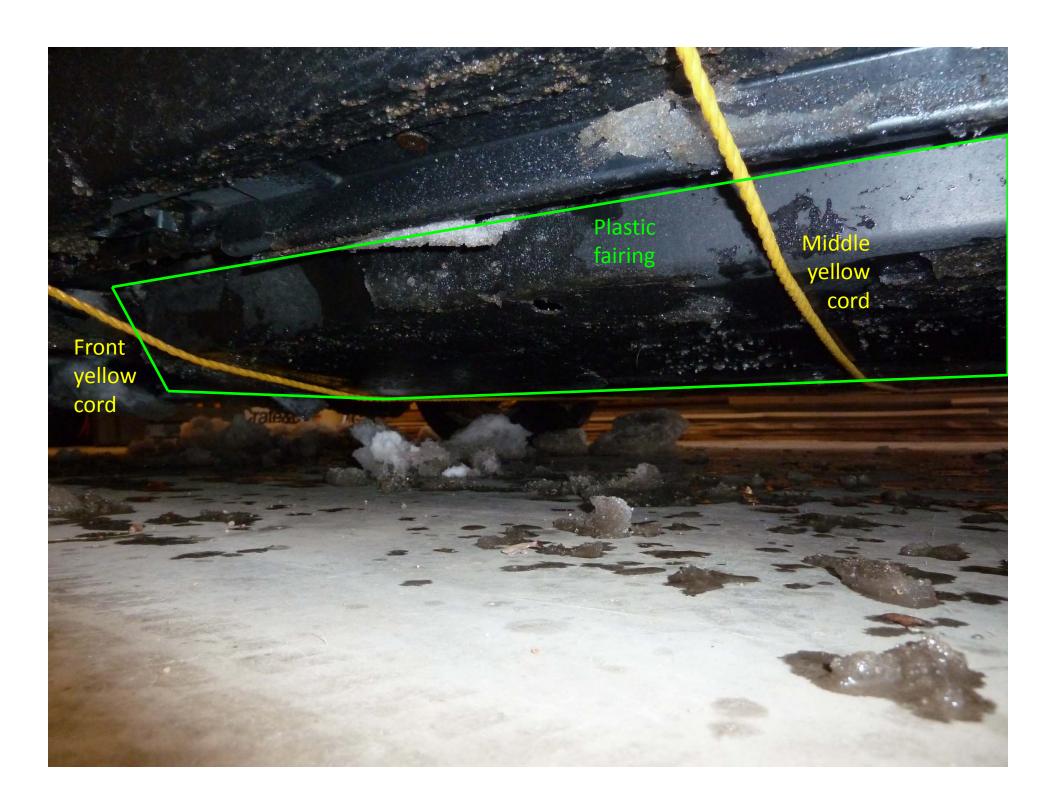
Finished fix, bottom view

Plastic fairing highlighted with green border
